EARTHQUAKE ENGINEERING RESEARCH LABORATORY

**ANALYSIS OF SIMULTANEOUS OPERATIONAL FAILURE
OF CRITICAL FACILITIES DUE TO EARTHQUAKE, FOR A
CALIFORNIA UTILITY**

**KEITH A. PORTER
SWAMINATHAN KRISHNAN
XIN XU**

REPORT No. EERL 2006-01

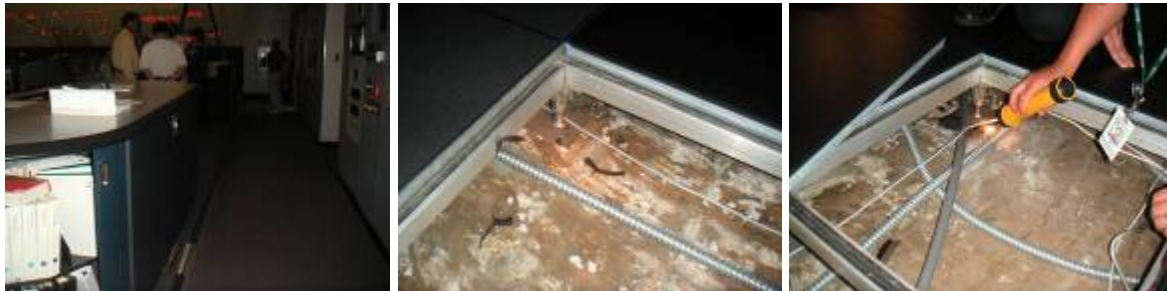
Figure 3-3. Grid control room and pedestals supporting its 3-in raised access floor

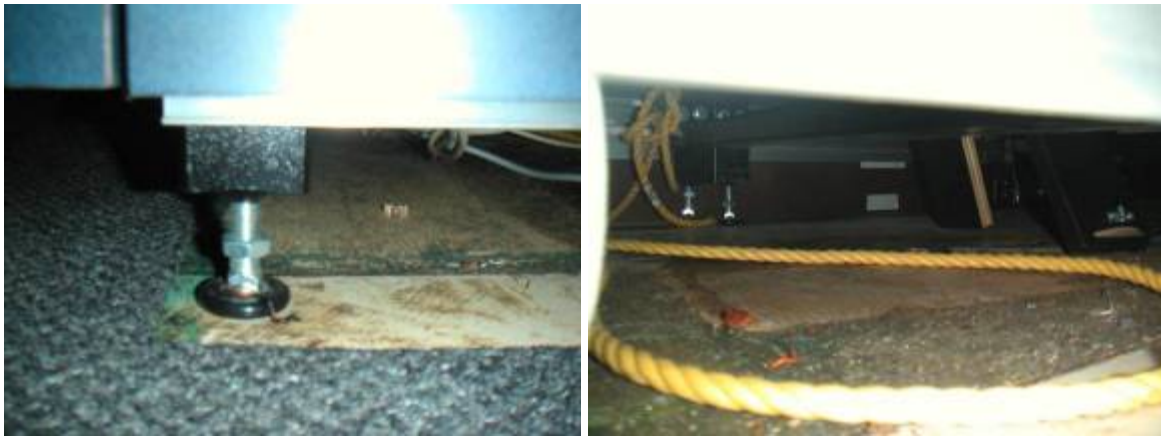
Figure 3-4. Grid control room consoles appeared to lack seismic restraint

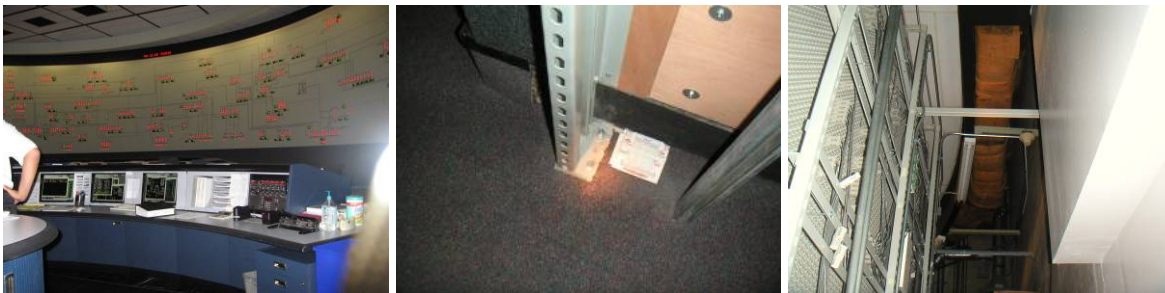
Some of the computer monitors and system units (the boxes that house the disk drives, system board, central processing unit, etc.) in the consoles were observed to be restrained against sliding, and some appeared to be unrestrained (Figure 3-5). Lack of restraint tends to increase the probability that the component will slide, overturn, and possibly cease to operate in the event of an earthquake. Unrestrained computers and monitors could be a weak link at this facility. The large display board contains a number of liquid crystal displays, which appeared to be well secured to a Unistrut steel frame, itself apparently anchored to the floor and wall (Figure 3-6).

Figure 3-6. Grid display board (left), and its restraint at bottom (center photo) and top (right)

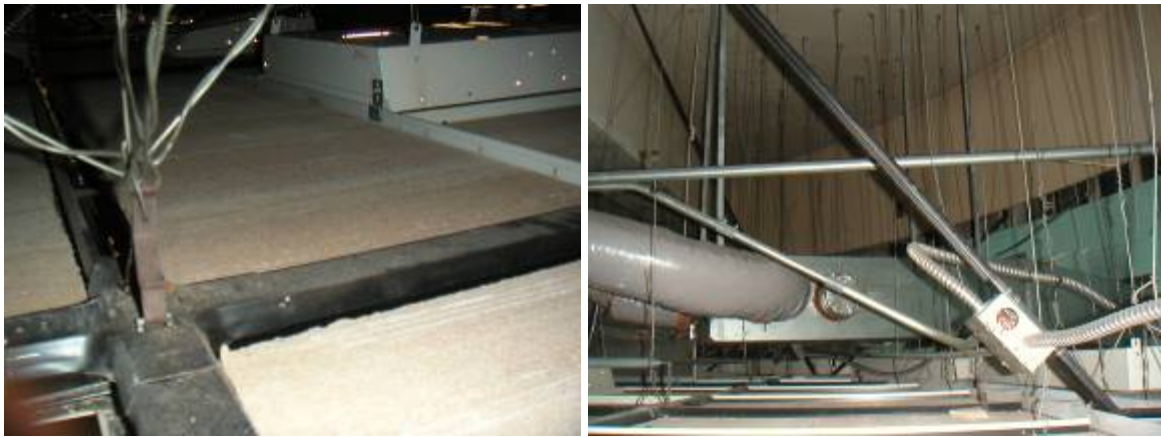
The overhead suspended ceiling system appeared to lack compression struts, although splay-brace wires were present (Figure 3-7). (Compression struts are rigid rods extending vertically from the ceiling framing members to the floor slab above, and are required by building codes for seismic resistance; the wires alone are considered inadequate to prevent ceiling collapse.) In practice, if the ceiling extends to the walls of the room, the walls tend to restrain (or “capture”) the ceiling more effectively than compression struts and splay braces, but the ceiling in this room does not extend to all the adjacent walls, and instead slopes up to the ceiling on the side of the room where one enters (i.e., opposite the display boards). Light fixtures near the point of observation had safety wires, used to inhibit the fixtures from falling if the ceiling collapses (Figure 3-8).

Figure 3-7. Suspended ceilings in grid control room.

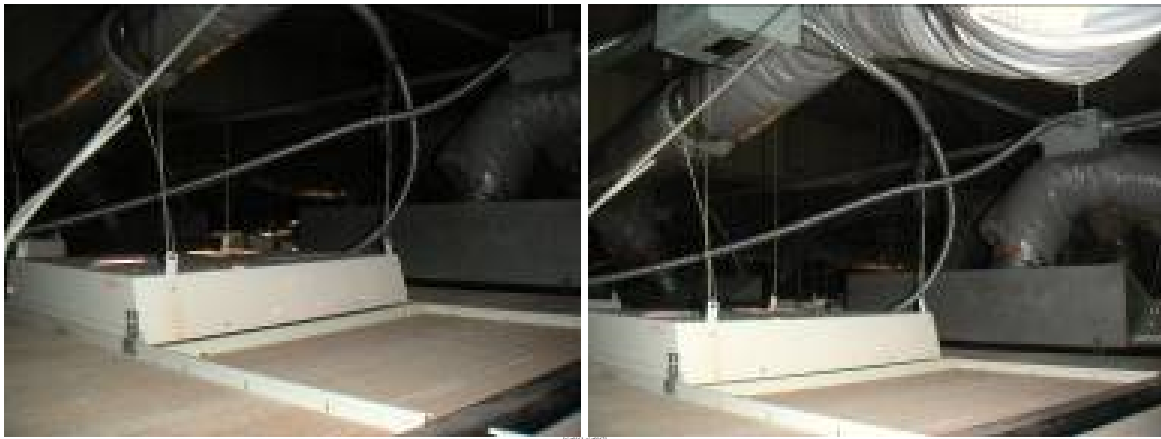
Figure 3-8. Safety wires observed on light fixtures in grid control room ceiling

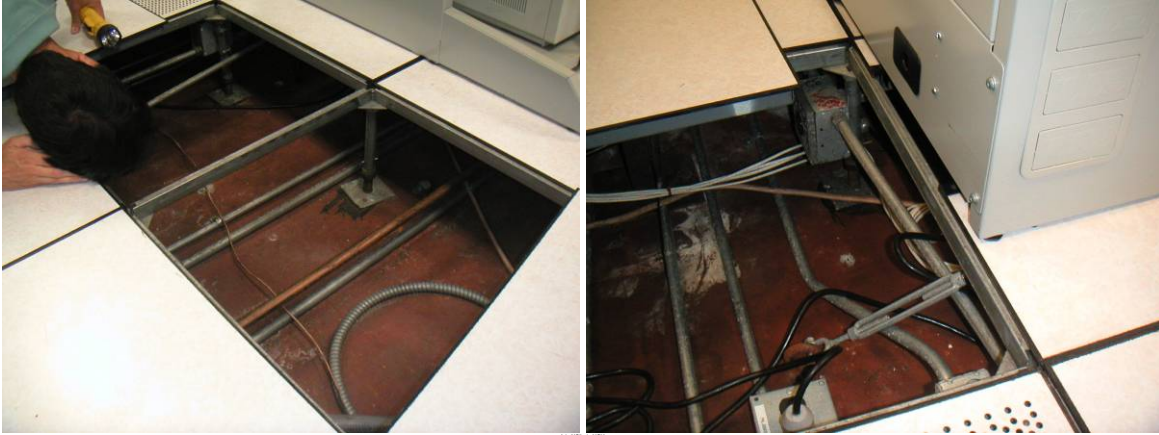
Figure 3-9. Anchorage of pedestals in main computer room raised access floor

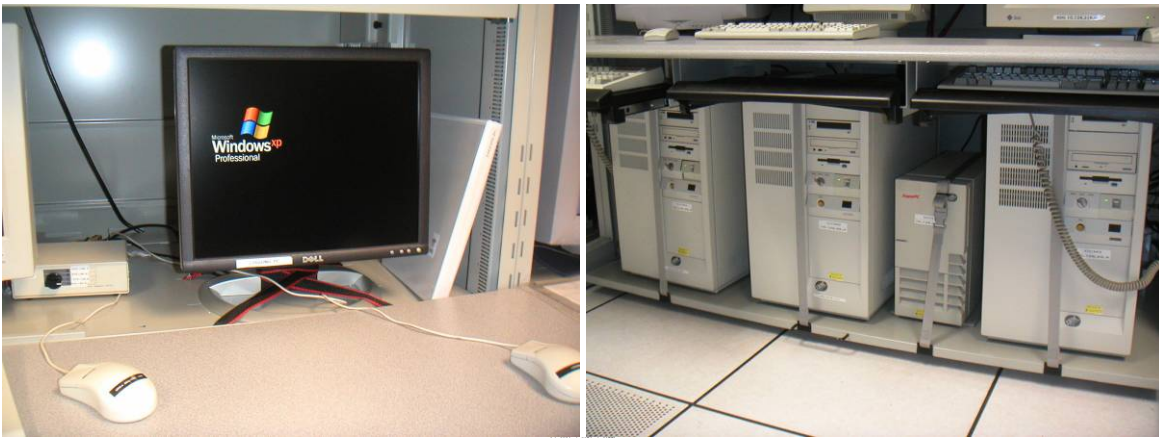
Figure 3-10. Restraint of computer equipment in main computer room

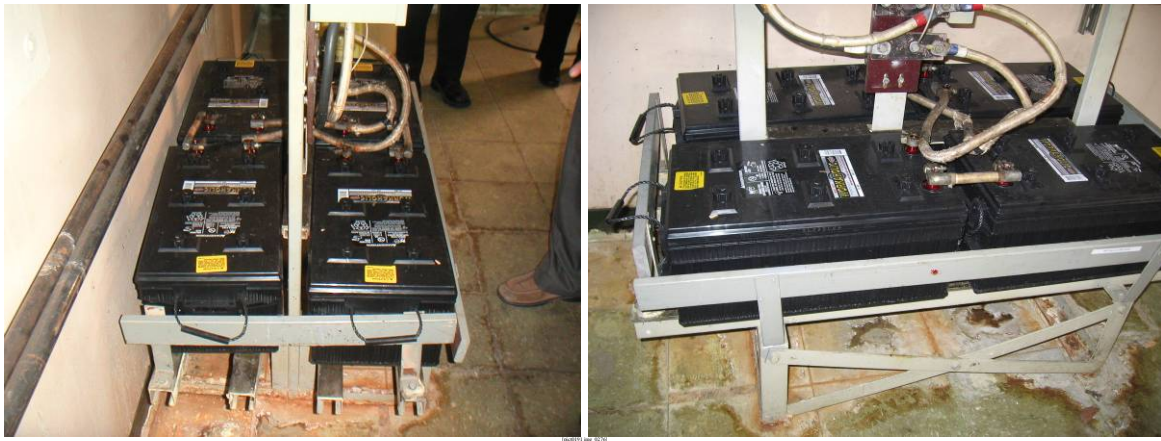
Figure 3-16. Battery rack for GCF generator starter motor was anchored but batteries lacked spacers

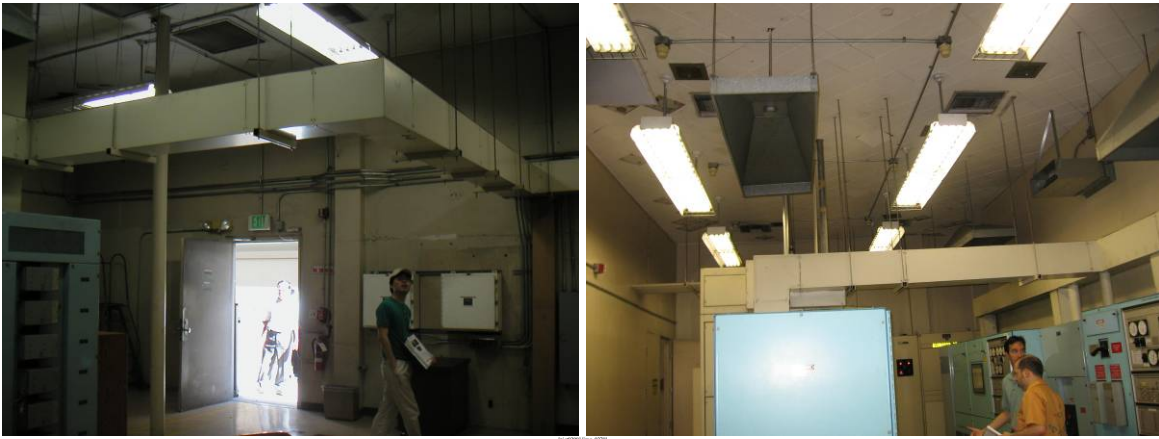
Figure 3-19. Cable trays and lights in GCF electrical equipment room

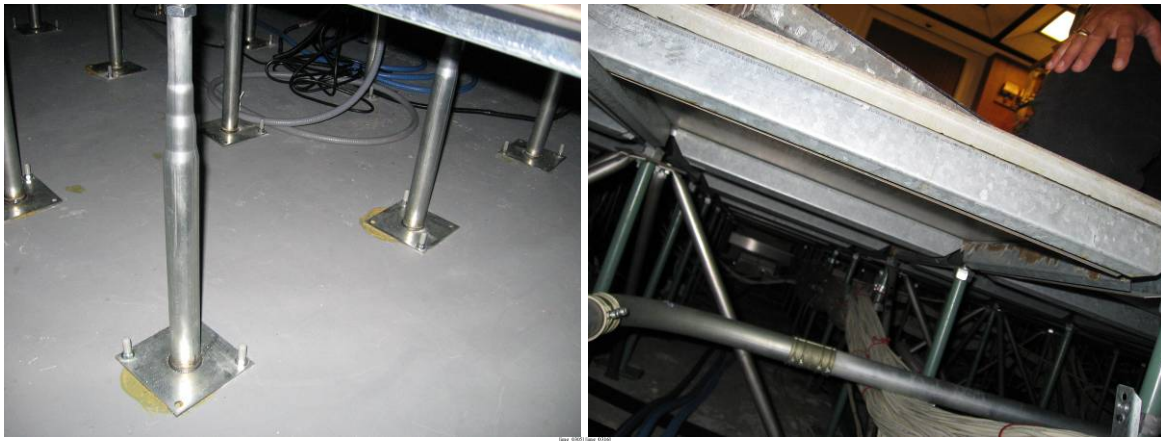
Figure 3-25. Raised access floor appears to be unbraced in ITOC room (left), although bracing is present in the ITOC equipment room (right).

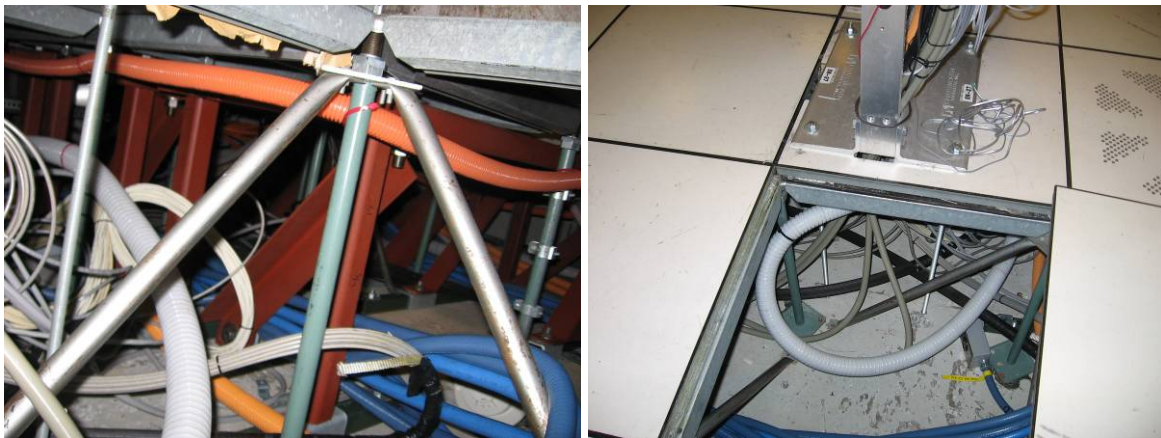
Figure 3-26. Red members behind the floor pedestal are steel framing to support heavy equipment in ITOC equipment room (left); lighter equipment secured with vertical rods (right).

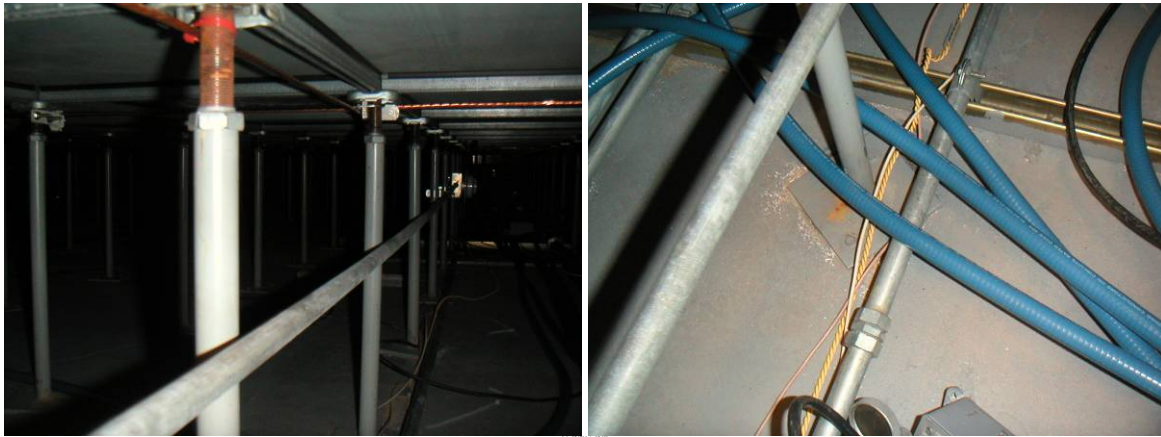
Figure 3-33. Raised access flooring in DPF tape silo room

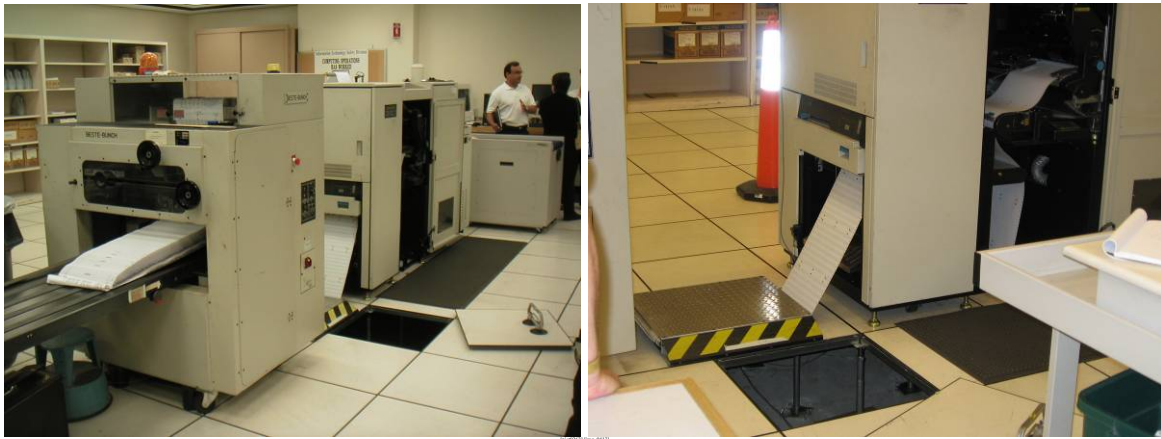
Figure 3-35. DPF printer room equipment

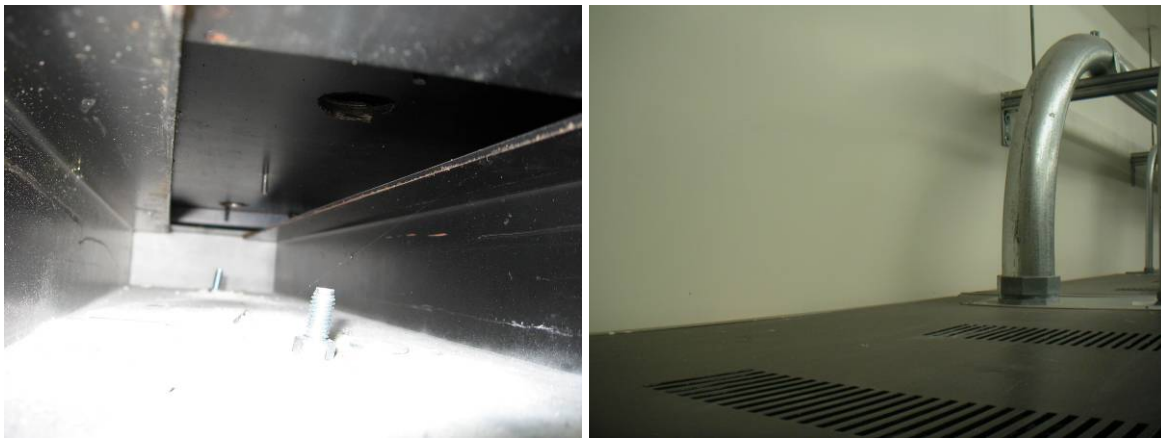
Figure 3-38. Apparent anchorage at base (left) but not at top (right) of DPF battery-rack cabinets

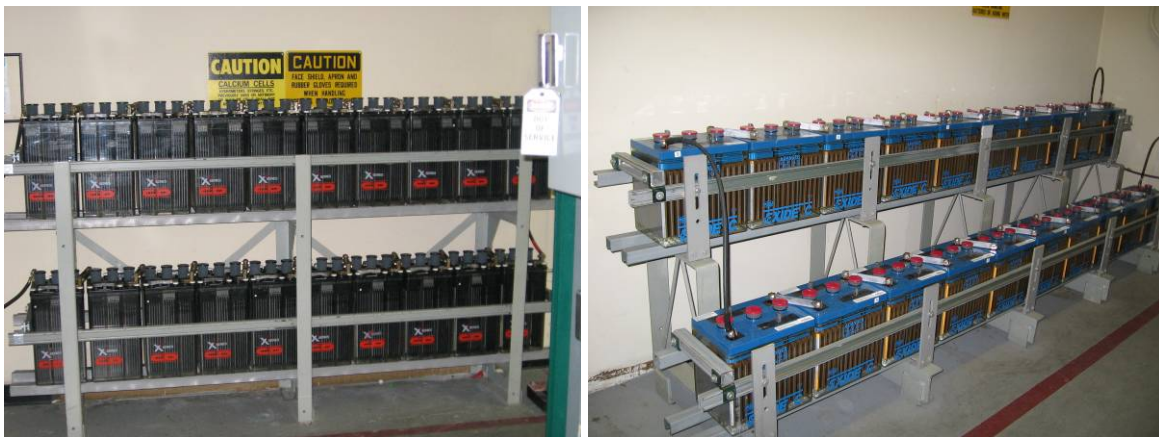
Breaker battery racks. We observed battery racks that building engineers suspected serve circuit breakers, as opposed to the main UPS (Figure 3-41). These racks have battery restraints and longitudinal braces but lack spacers between the batteries. Spacers (often Styrofoam sheets placed between batteries) are an attempt to prevent the batteries from shifting within their frame and breaking the conductors between adjacent batteries. The lack of spacers increases the probability that an earthquake would damage the conductors and prevent the battery rack from supplying power; this shortcoming may be a weak link at this facility.

Figure 3-41. Battery racks serving breakers

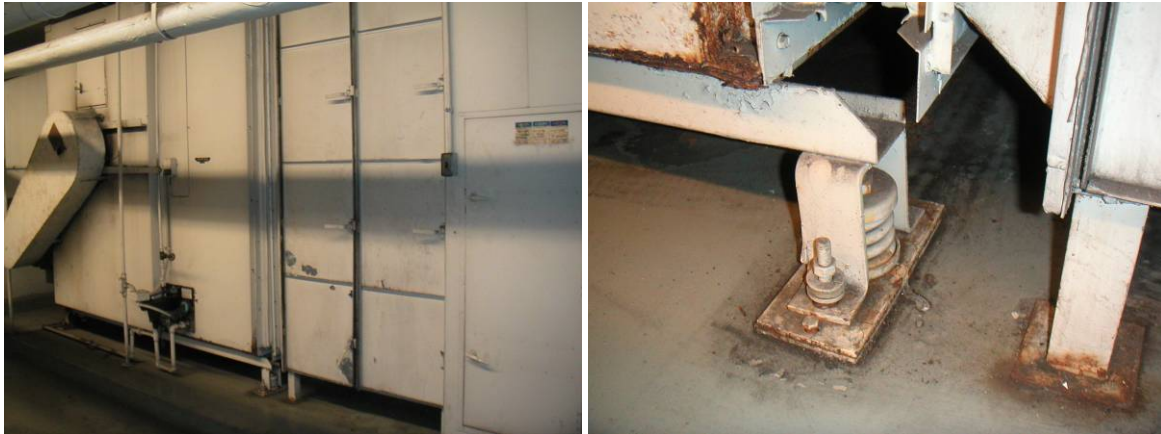
are on vibration isolators without seismic snubbers (Figure 3-42). (Seismic snubbers are metal fixtures attached to the slab next to a vibration-isolated mechanical device to restrain the device's lateral movement; an example is shown in Figure 3-43). The AHUs are rigidly attached to piping that could be damaged by excessive displacement of the AHU in an earthquake (Figure 3-44), which is another issue that tends to raise the probability of operational failure. Note that two of the four AHUs are needed. Lack of seismic restraint for these AHUs is a potential weak link at this facility.

Figure 3-42. Air handling units in DPF on isolators apparently without seismic snubbers

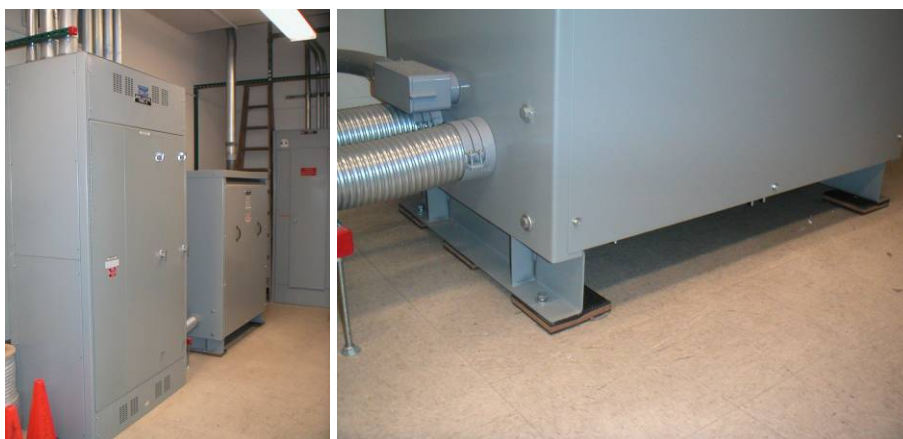
Figure 3-48. Anchorage of electrical equipment near DPF generator

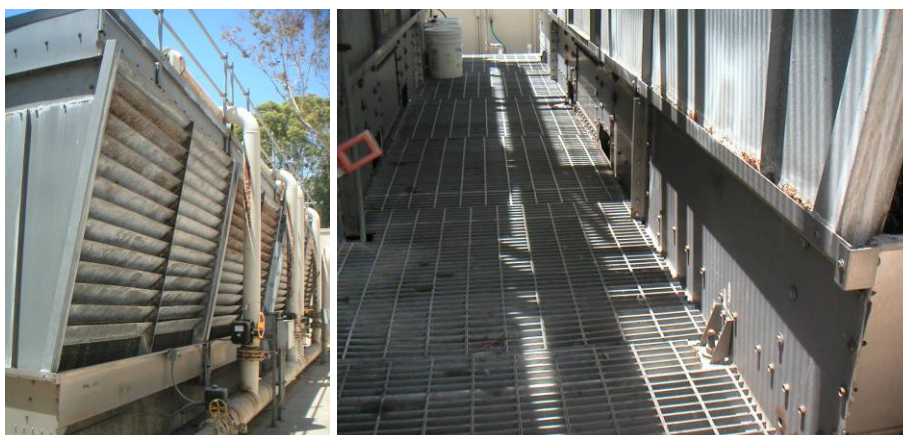
Cooling towers at DPF appeared to be seismically anchored. DPF does not have an on-site water supply, and it is of concern that if the local water supply is interrupted in an earthquake, evaporation of the water in the cooling towers could render the air conditioning at this facility inoperative; this may be a weak link at this facility, which could be remediated by providing a backup water supply for the cooling towers.

Figure 3-49. Cooling towers at DPF and their anchorage. This facility lacks an on-site backup water supply in case the local water utility is damaged.

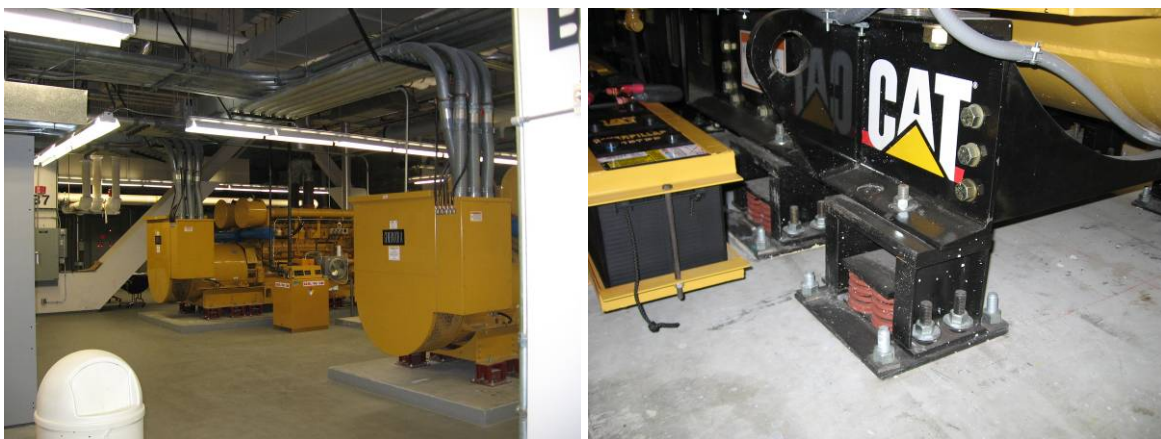
Figure 3-50. Generators and their seismic isolators at BDF

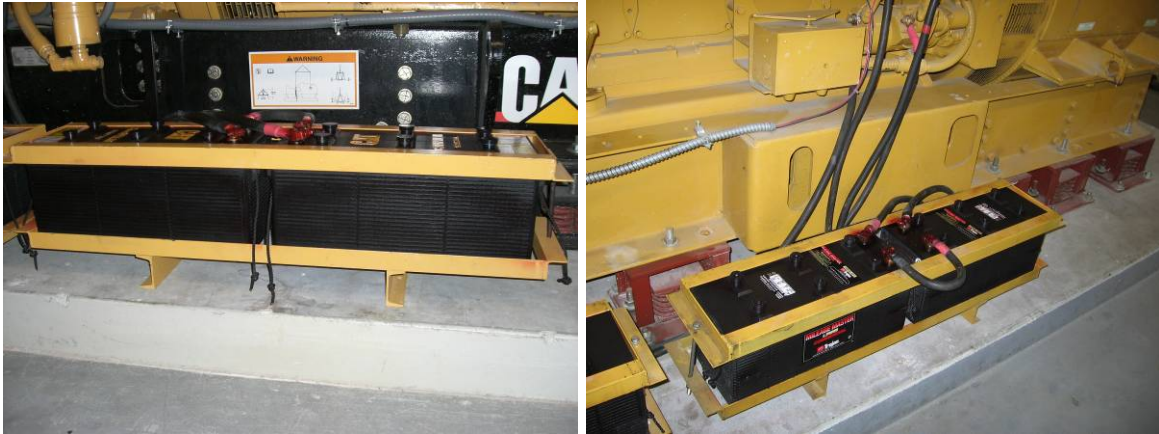
Figure 3-52. Apparently unanchored starter-motor batteries for generators at BDF

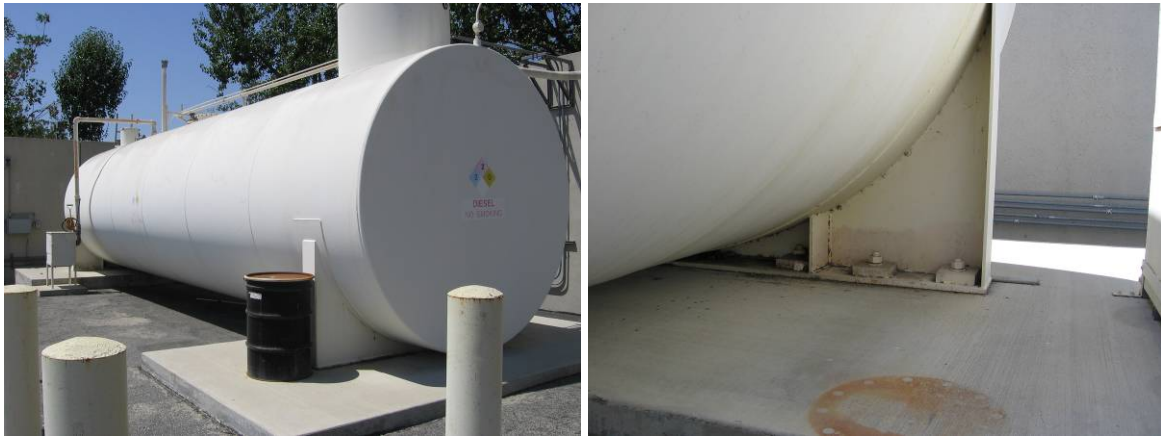
Figure 3-53. Diesel fuel tank at BDF apparently anchored to its plinth

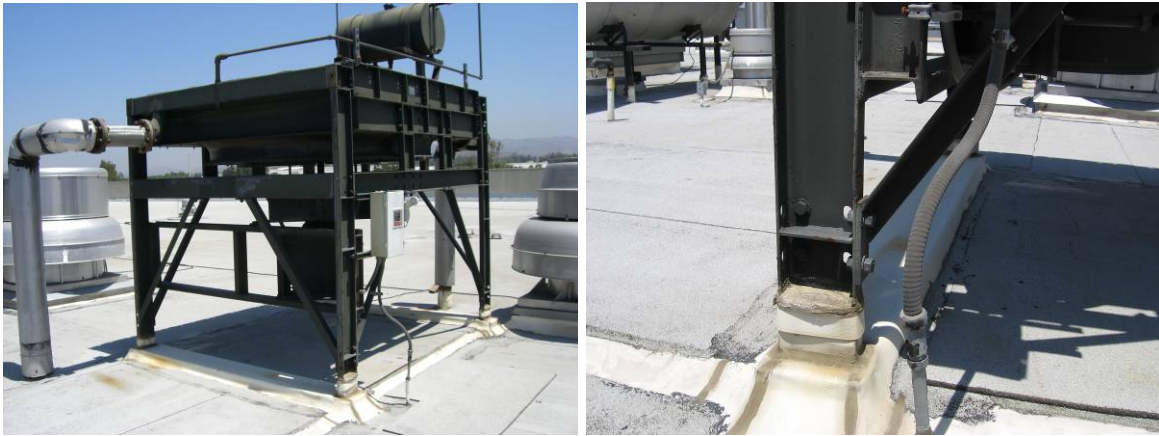
Figure 3-56. Radiator for BDF emergency generator

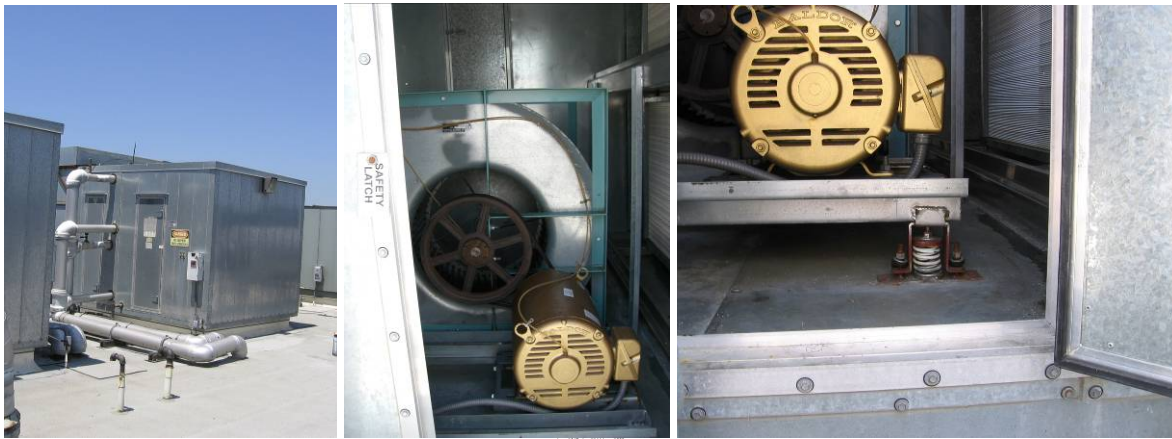
Figure 3-58. Enclosure with generator air supply fan and pre-cooling equipment. Isolator appears to have questionable seismic restraint

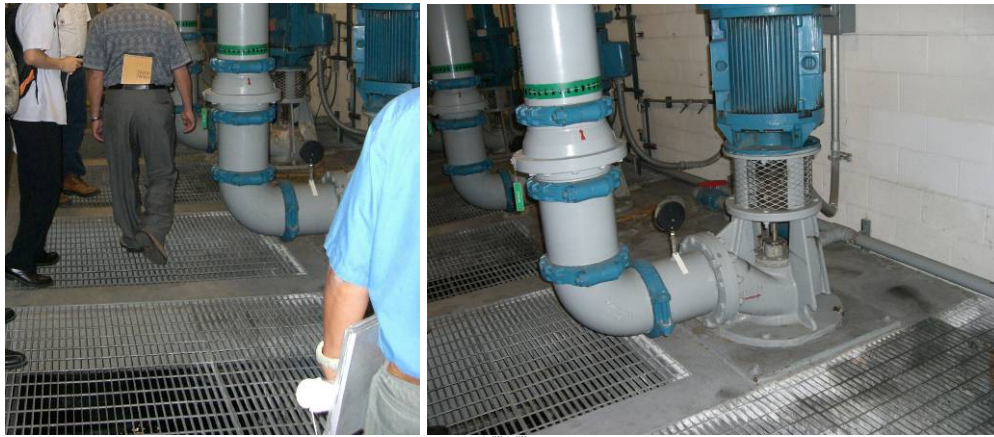
Figure 3-60. On-site water supply at BDF for use by cooling towers

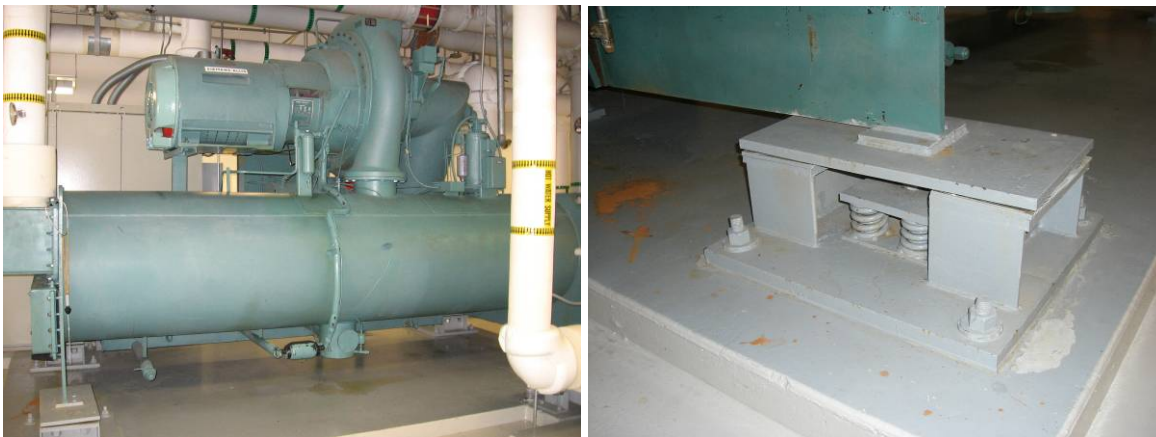
Figure 3-61. Chillers and their seismic anchorage in BDF

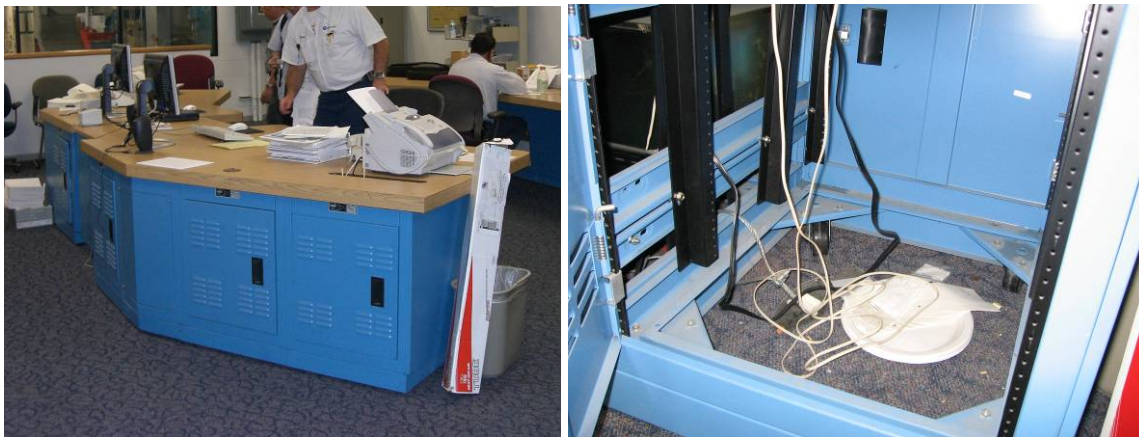
Figure 3-65. Desks in BDF building control room appeared to be tethered to the slab

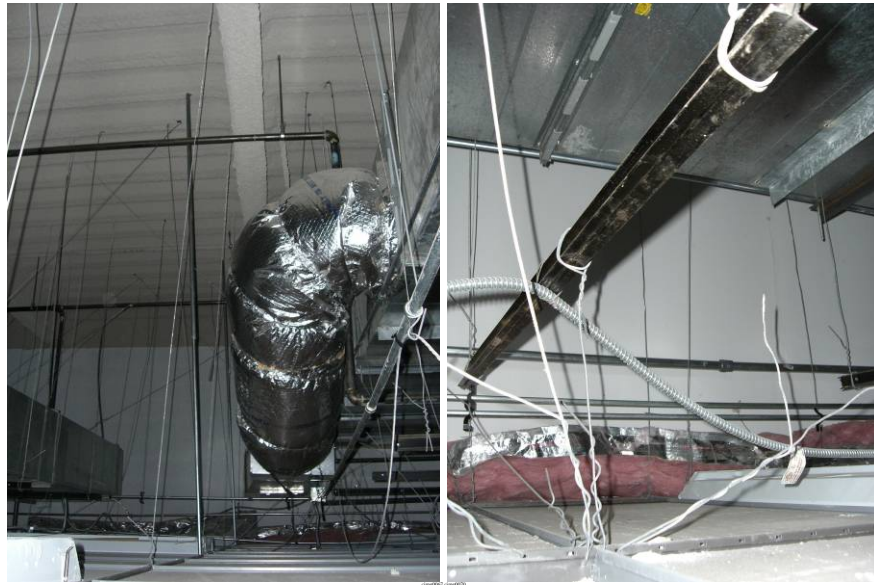
Figure 3-67. Compression struts and diagonal splay wires in BDF building control room ceiling

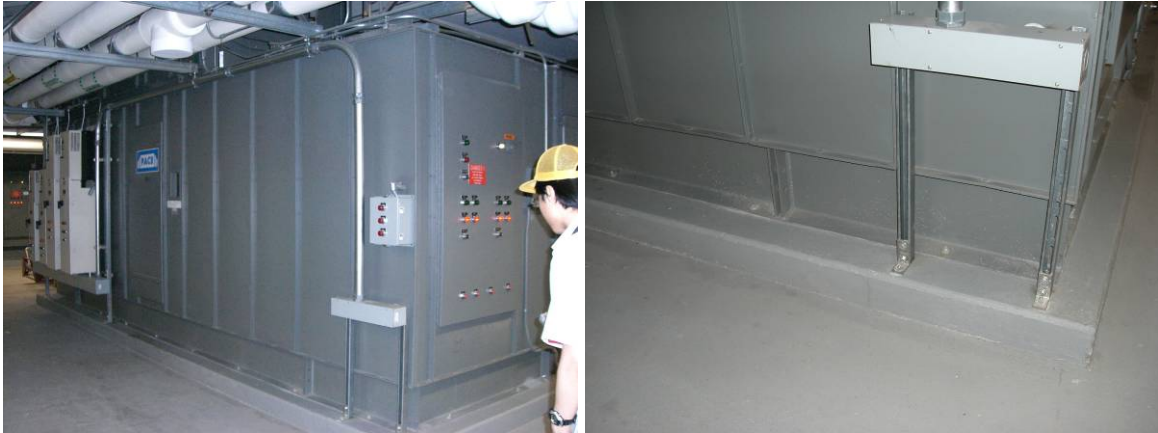
Figure 3-70. Air handling units in BDF appeared to be anchored to their plinths

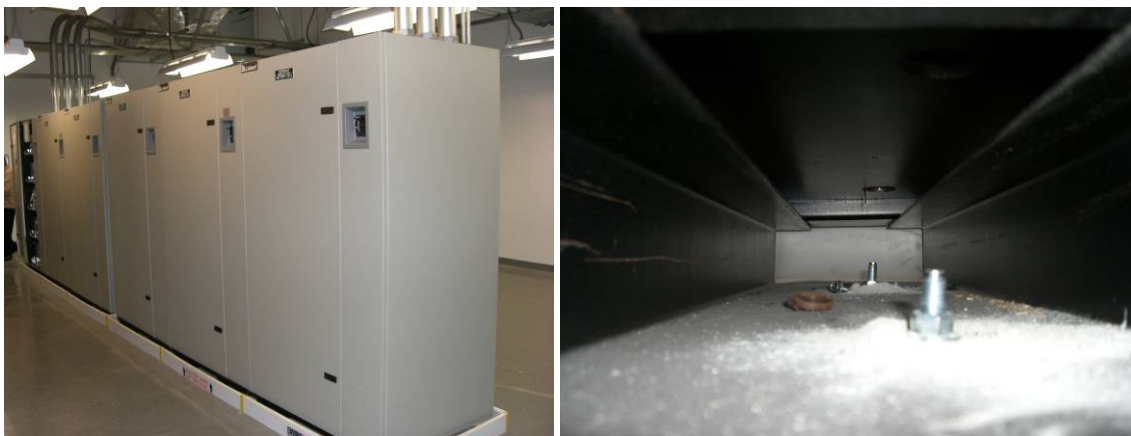
Figure 3-71. UPS equipment apparently anchored to slab

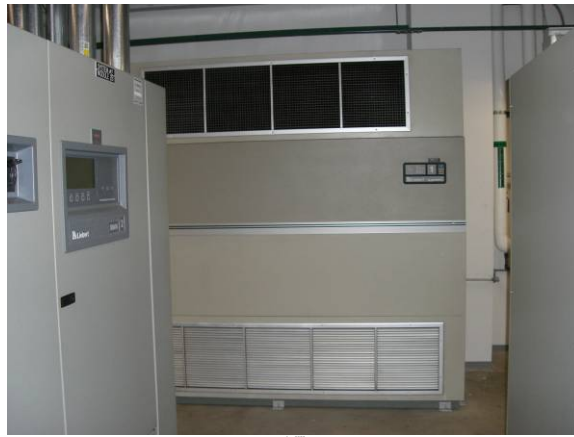
Figure 3-75. Air conditioning equipment near BDF UPS cabinets, apparently anchored to the slab

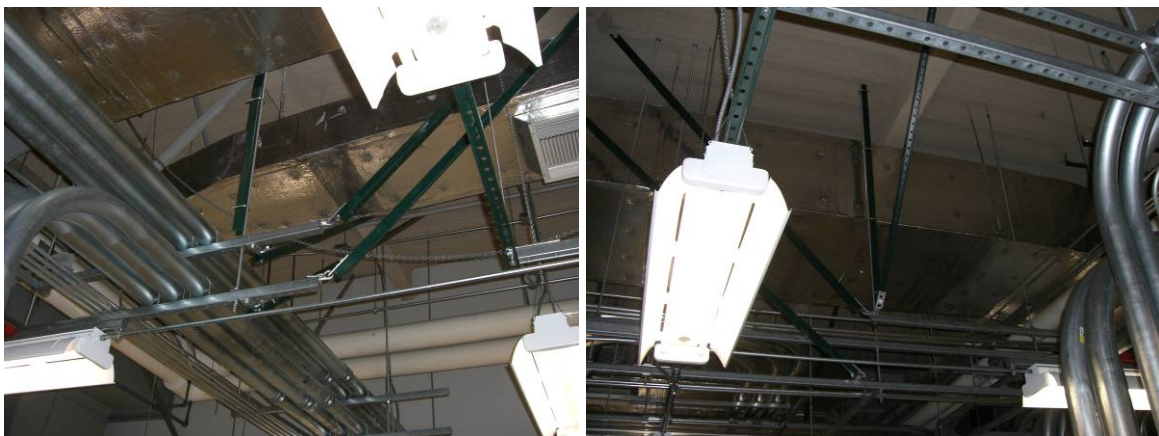
Figure 3-76. Overhead electrical ducts and hanger braces at BDF

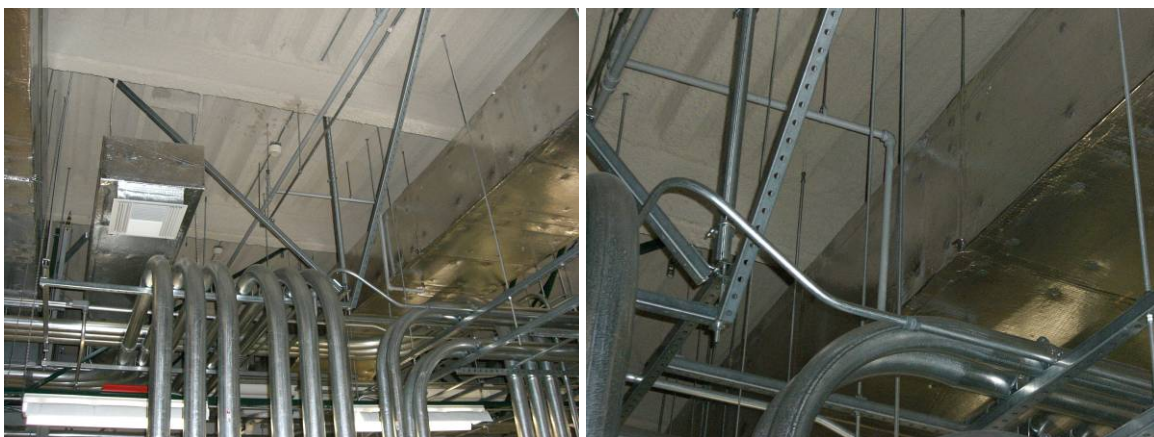
2. Long unbraced runs of sprinkler pipe were observed in some critical areas, and in many places there appeared to be potential for interaction between sprinkler pipe and ventilation ducts. In some of these areas, sprinklers are wet systems, meaning that damage to pipes could release water on sensitive electrical equipment below.

Overhead electrical ducts were observed to be supported on braced hangers (Figure 3-76). However, the fire suppression system in the 2nd floor mechanical spaces is provided by automatic sprinklers (charged, wet lines), with long unbraced runs of pipe in excess of 20 ft. In several spaces these pipes were observed to be located near unbraced ductwork (Figure 3-77) that in an earthquake could interact with and possibly break the sprinkler pipe, which could lead to water spraying on UPS and other electrical equipment. This appeared to be a common situation throughout the building: braced electric conduit hangers and cable trays, but unbraced automatic sprinkler lines and air-conditioning ducts. The potential for earthquake sprinkler leakage caused by damage to sprinkler pipe may be an important weak link at this facility, especially in areas with electrical equipment. Damage to air ducts aggravated by lack of bracing could also pose a serious problem for air conditioning in computer spaces.

Figure 3-77. Long unbraced sprinkler lines and places where they could interact with ductwork

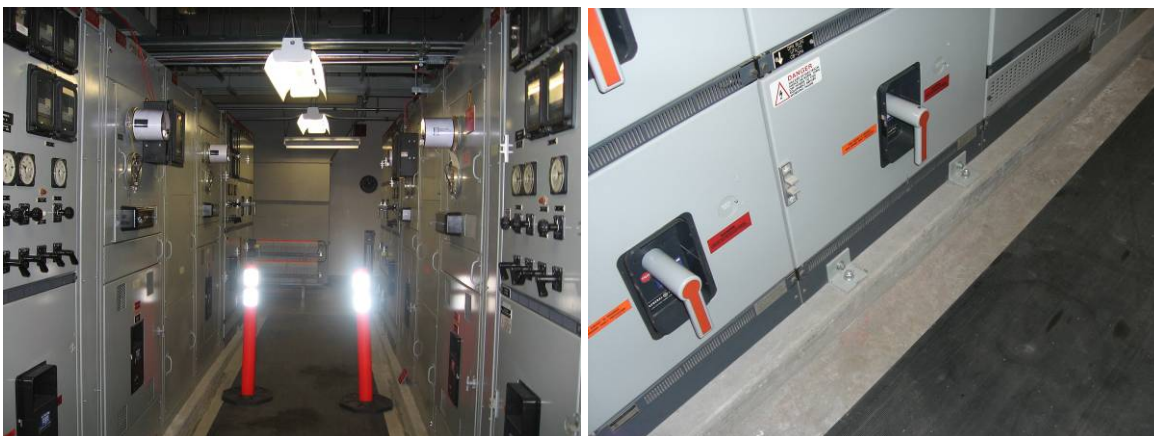
Figure 3-78. BDF switchgear and its anchorage

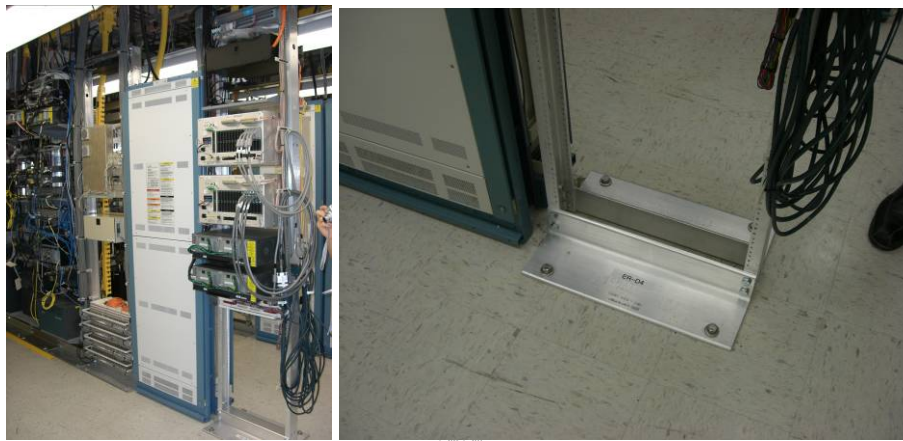
Figure 3-80. Telecommunications equipment at BDF and its anchorage

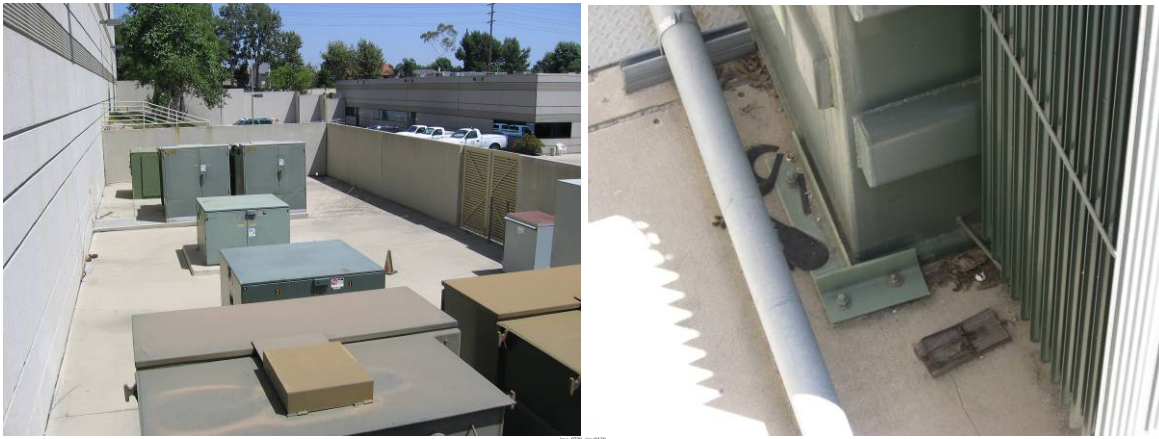
Figure 3-85. Transformer vault at BDF, and apparent seismic restraint of its equipment

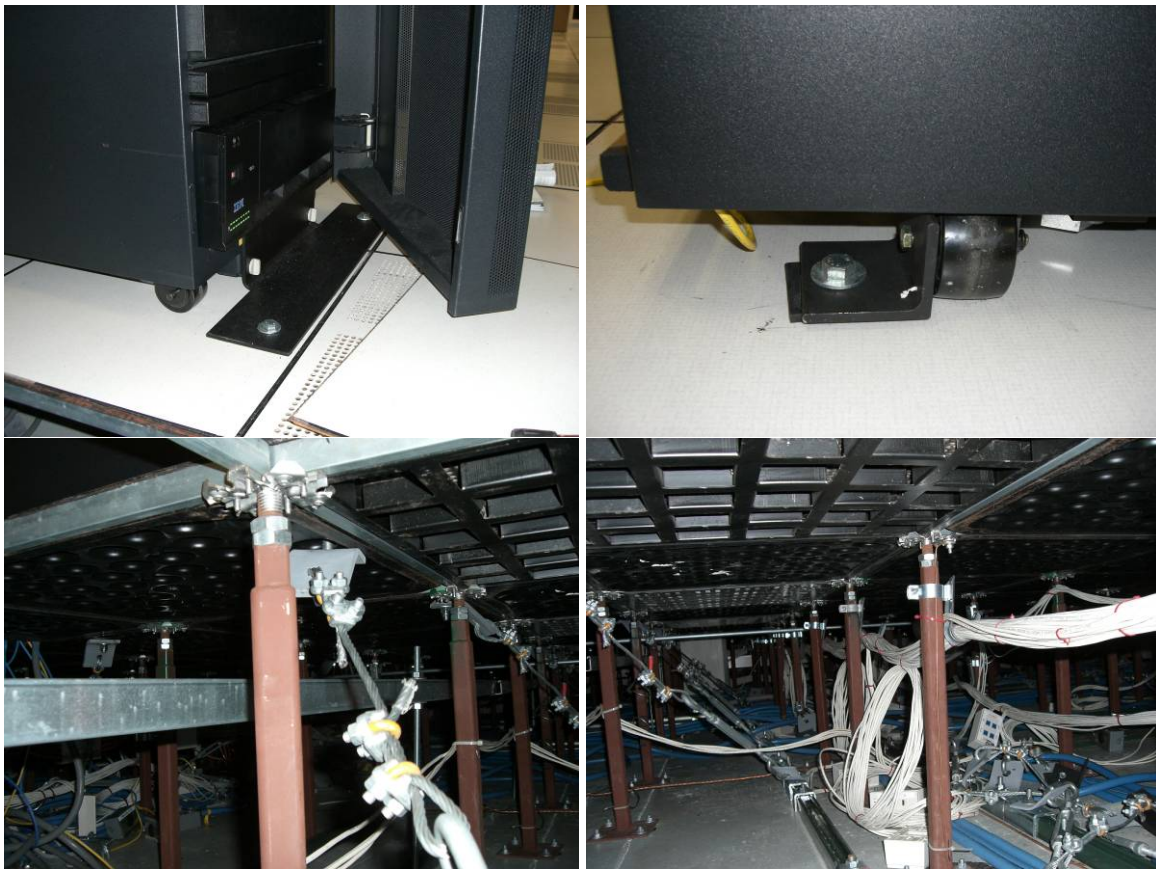
Figure 3-87. System of tethering computer equipment to slab below raised access floor in BDF CPU room

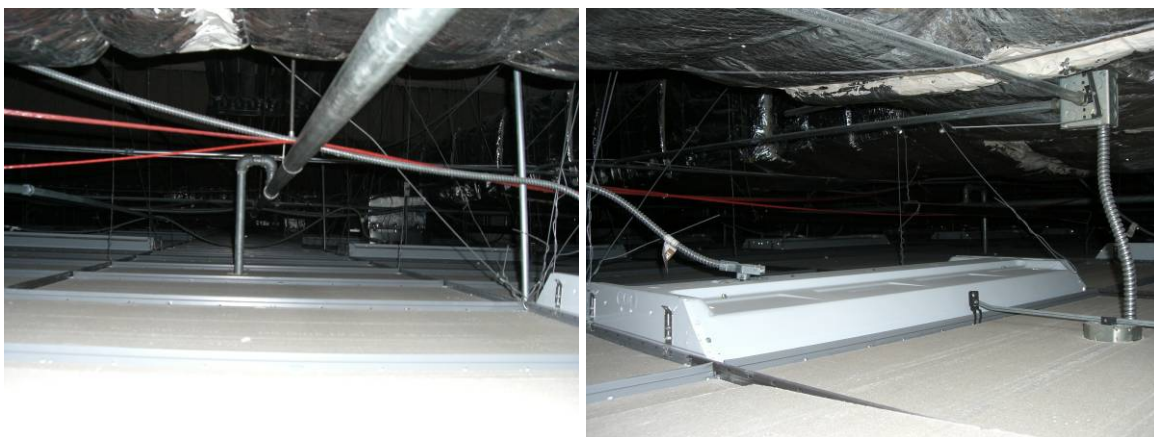
Figure 3-88. Ceiling in the BDF CPU room with compression struts, splay wires, and safety wires on light fixtures

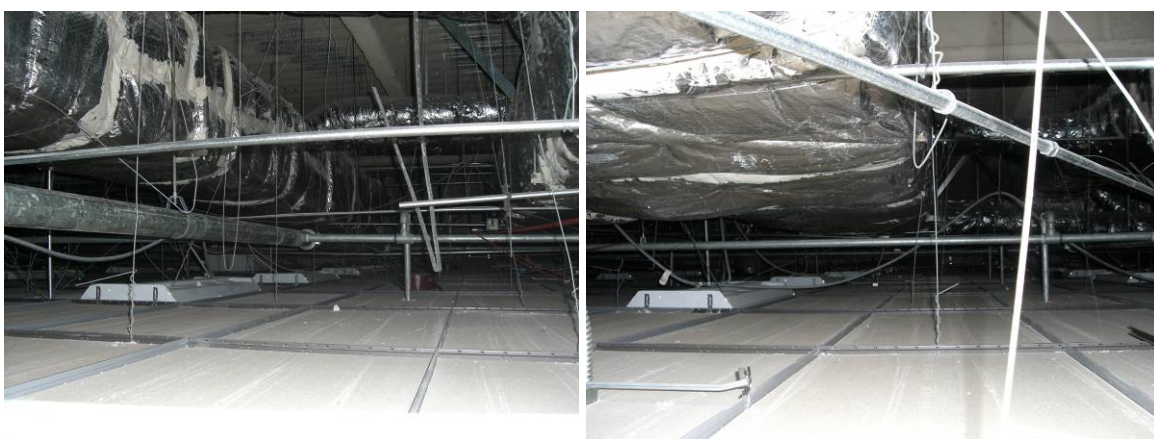
Figure 3-89. Ductwork and sprinkler pipe at BDF CPU room

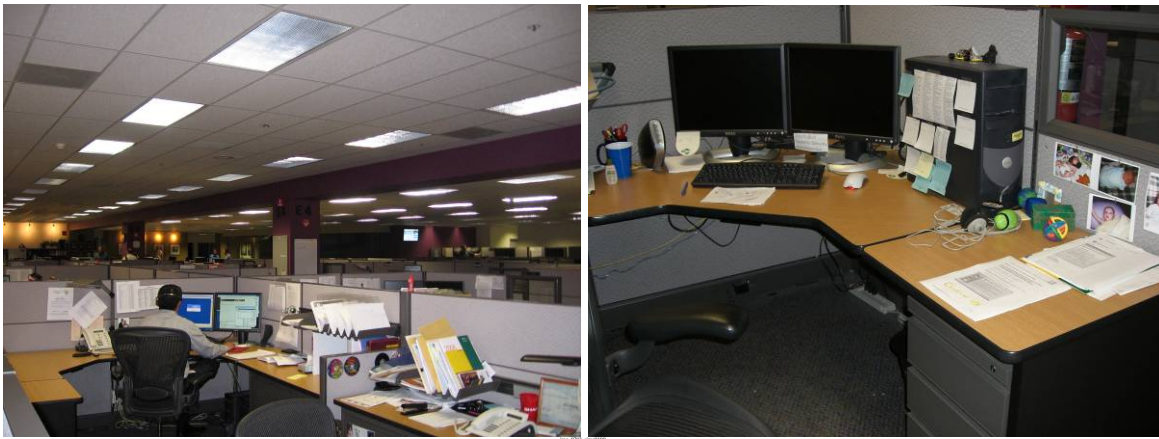
Figure 3-90. BDF helpdesk center and apparently unsecured computer equipment

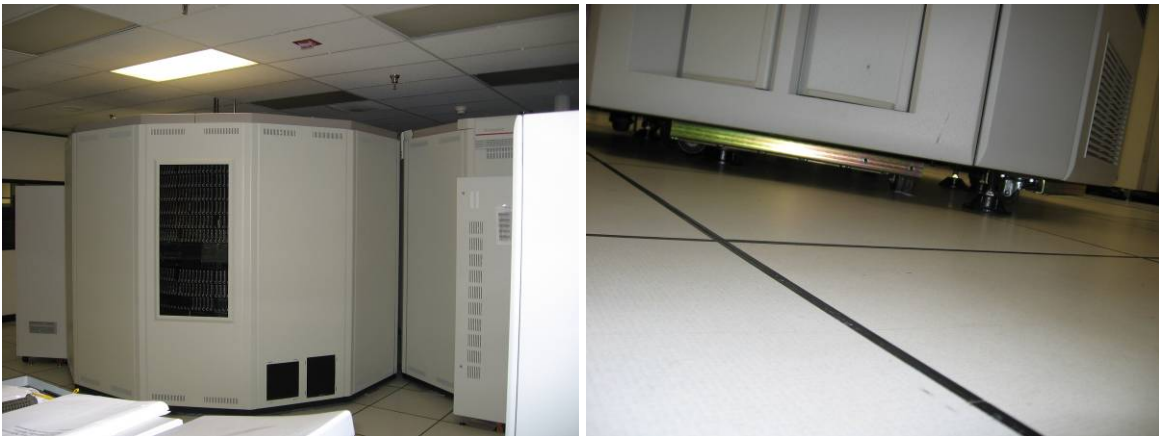
Figure 3-92. Apparently unrestrained BDF tape silos

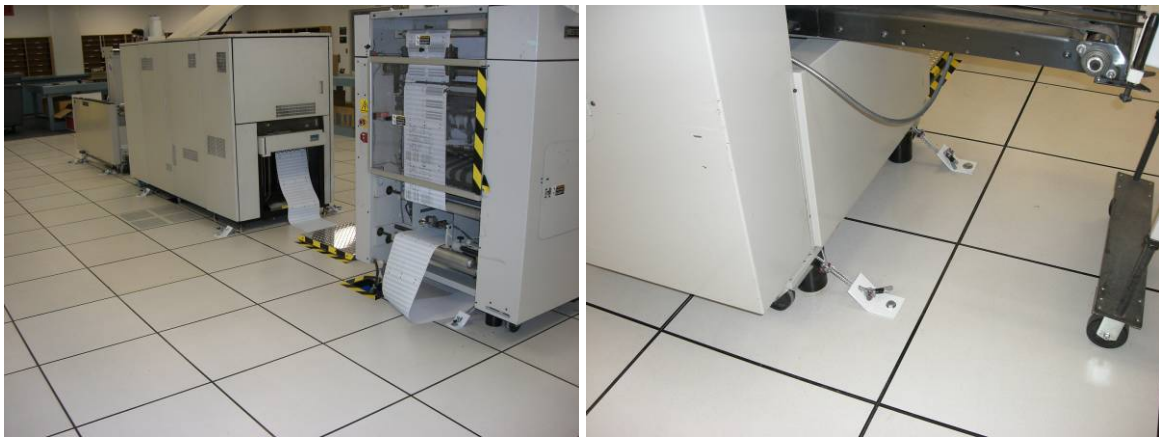
Figure 3-93. Document handling equipment in BDF restrained to raised access floor
